Match Mortars

Brick Stone Pointing

At Match Mortars our aim is to help home owners understand the problem and offer them the solution.

If you own a sandstone building and you have decaying sandstone you will find the problem causing the decay in these pages.

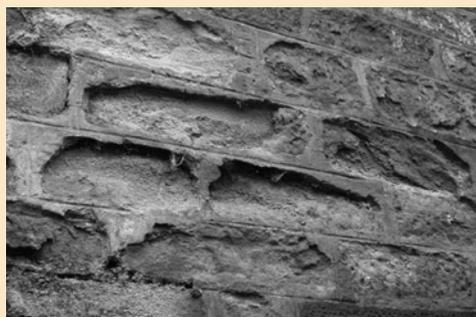
Other defects include pieces of sandstone falling away from the underside of cornices, lintels and other blocks that project from the wall. Facing up in cement mortar is a common response but, for the reasons just described, it is not a proper repair. It is also common to find cement mortar used for pointing on sandstone walls. As with cement mortar facing, its undesirable effects are only too evident. Its use leads to the same problems of failure of the cement mortar, trapping of water within the wall and further damage to the sandstone itself. Look at any sandstone wall where there is evidence of surface decay and it will become clear that many have been pointed with cement mortar. The damage that cement mortar facing and pointing can cause is made much worse in areas that are subject to repeated washing with water. If the wall is faced or pointed with cement mortar, the rate of decay increases significantly. The clay minerals expand and contract repeatedly leading to increased delaminating of incorrectly bedded blocks and contour scaling of blocks that are correctly bedded. When the temperature drops to freezing point any water trapped in the wall freezes and expands causing further damage, commonly around the area where the sandstone and the cement mortar meet. In walls where cement facing and pointing is extensive, water can build up inside the wall and fungal decay can develop in the internal timbers of the building. All of this is caused by dense cement mortar blocking the free evaporation of moisture from the wall because the wall cannot breathe in the way it was designed to do.

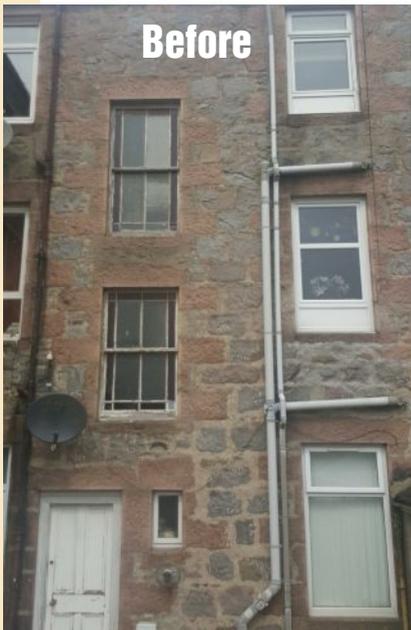
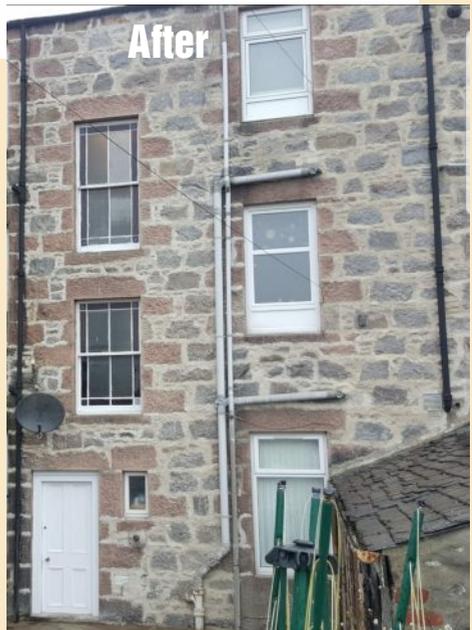
The solution

Sandstone pointing with lime mortar.

Masonry walls need to be maintained and repaired, just as roofs and rainwater goods do. Where walls are solid, without a cavity, keeping them in good repair is necessary for the interior to remain functional and dry. Pointing is the most common repair, and often one of the most poorly executed.

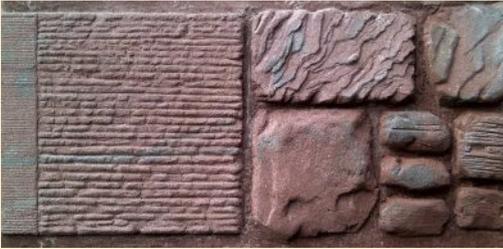
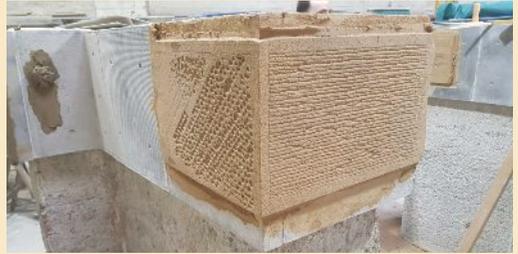
**With Lithomex (see below) this what can be created;
The appearance of natural stone.**

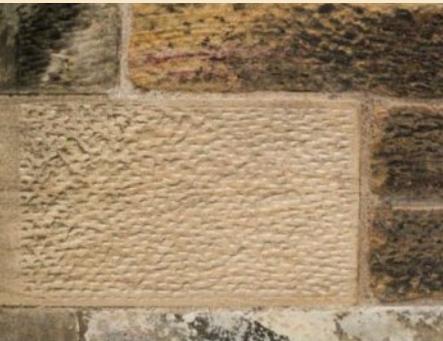
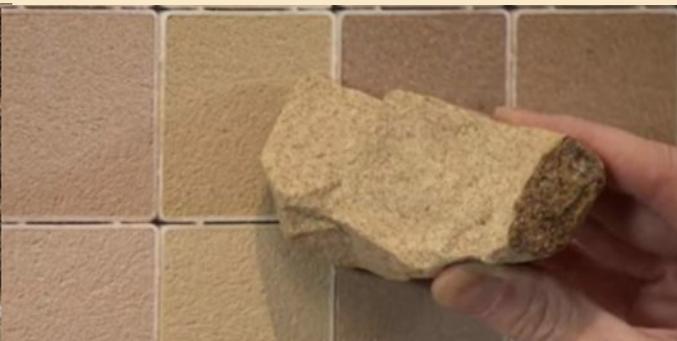
**Lithomex comes in a variety of natural colours,
which can be matched to your existing colour of stone.**

Whether sandstone granite or clay brick.
